# REPORT

Datum / *Date*                      Beteckning / *Reference*                      Sida / *Page*  
2001-12-11                      P106036A                      1 (4)

## Impact test, electrical wheelchair and locking device

Impact test on a wheelchair Model MC Skubber and floor pocket system model Qstraint Q-5001 according to ISO-10542.

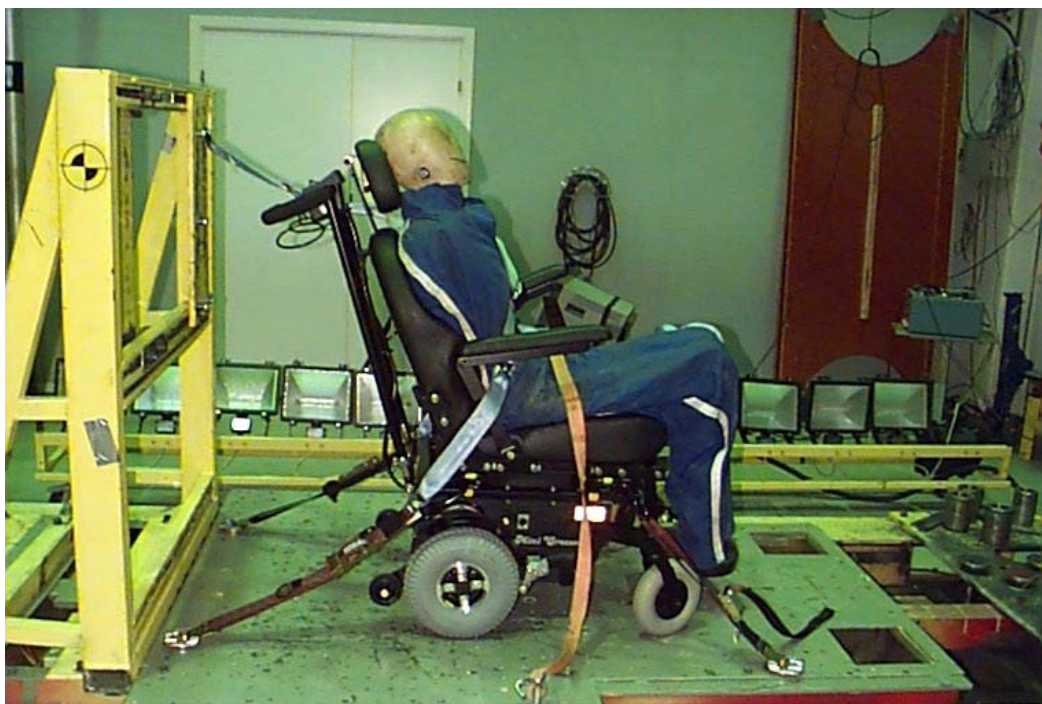
After the test, all components were intact. No fractures or damages could be observed on the tested objects. The wheelchair was fit to drive after the test.

After test.

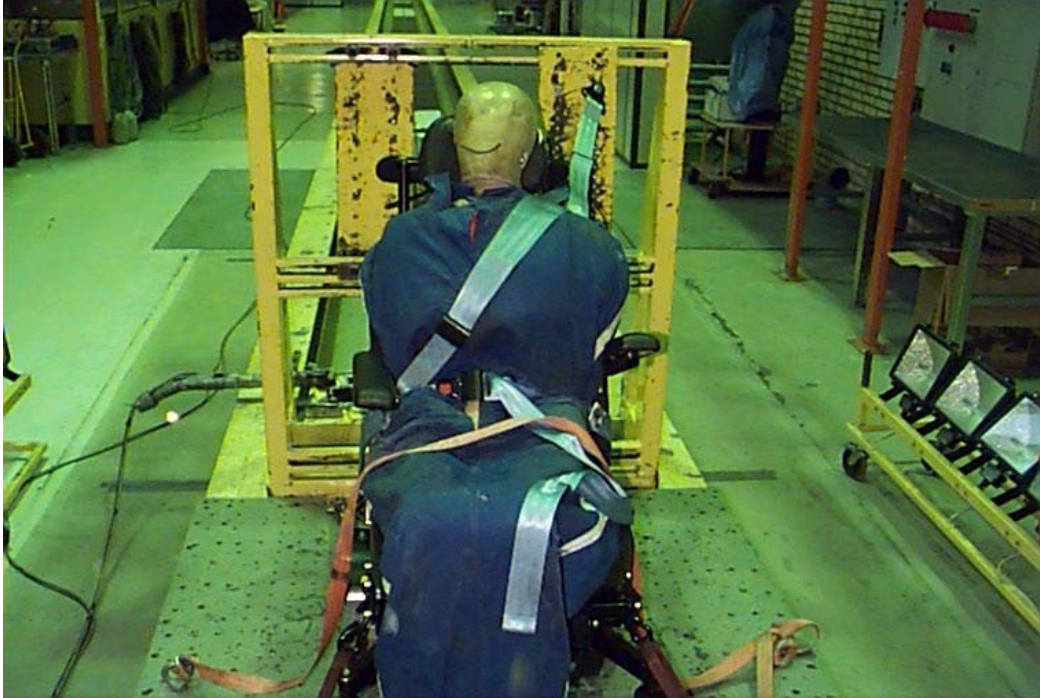
After test.
