Crash Test according to ISO 7176-19

Wheeled mobility devices for use in motor vehicles

Test Report no: 06122006 Minicrosser

Test object: Minicrosser 1103 Ultra

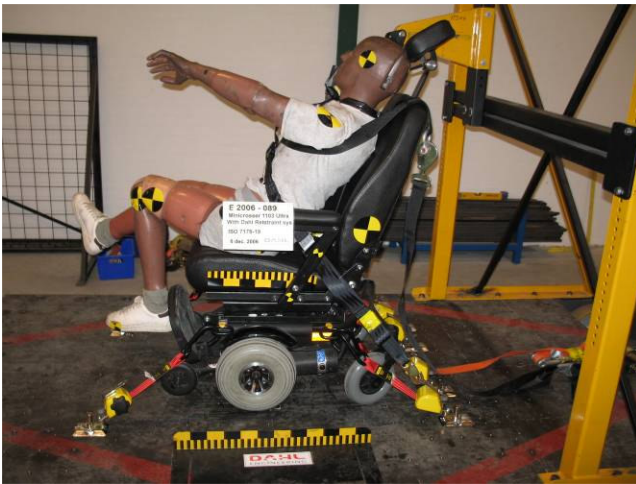
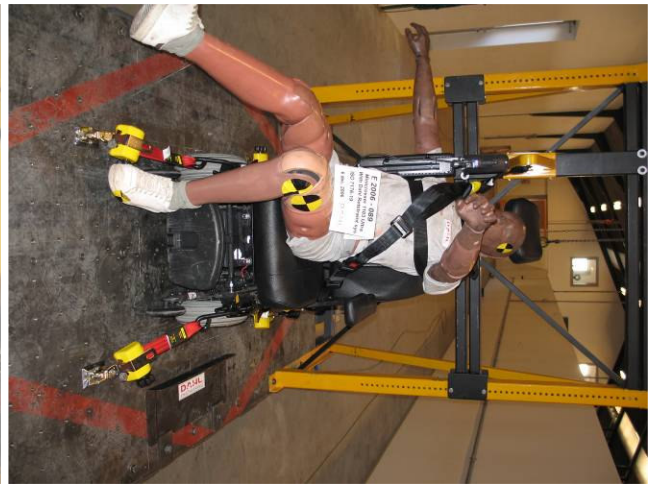
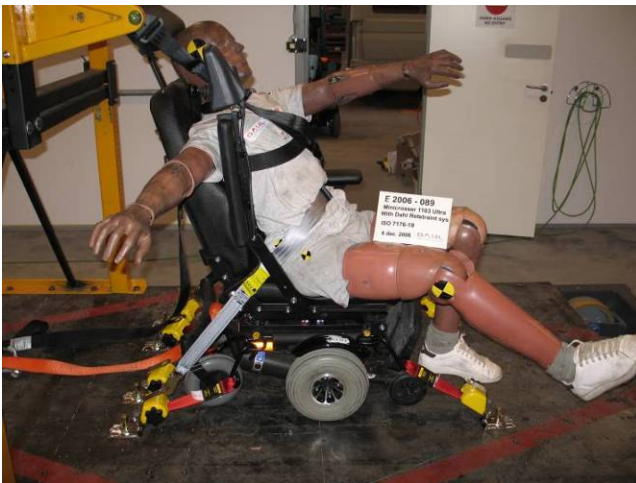
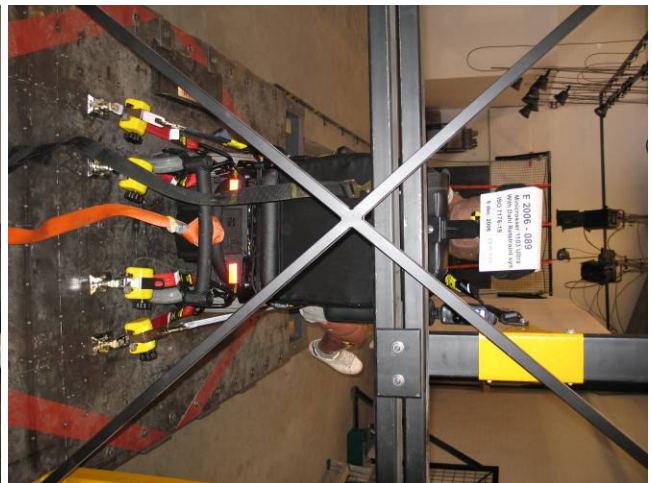
Post test photo's

5.2.2	After the test	
(a)	The wheelchair remained in an upright position on the platform	X
	The ADT remained in the wheelchair with its torso at an angle of not more than 45° to the vertical, when viewed from any direction	X

(b)	There were no visible signs of material failure on the wheelchair securing points	X
(c)	There were no components, fragments or accessories of the wheelchair with a mass of more than 100g that completely separated from the wheelchair	X

(d)	There were no fragmented or separated component, that may contact the occupant, produced with sharp edges less than radius 2 mm	X
(e)	There were no visible signs of failure on the wheelchairs primary load carrying components	X

The presented samples meet the requirements set out in the ISO standard 7176-19.
